CAUSES OF CRACKING OF IGNITION CABLE.

By  
J. B. Dempsey  
F. B. Silsbee,  
Aeronautic Power Plants Section,

February, 1921.

TECHNICAL NOTE NO. 32.

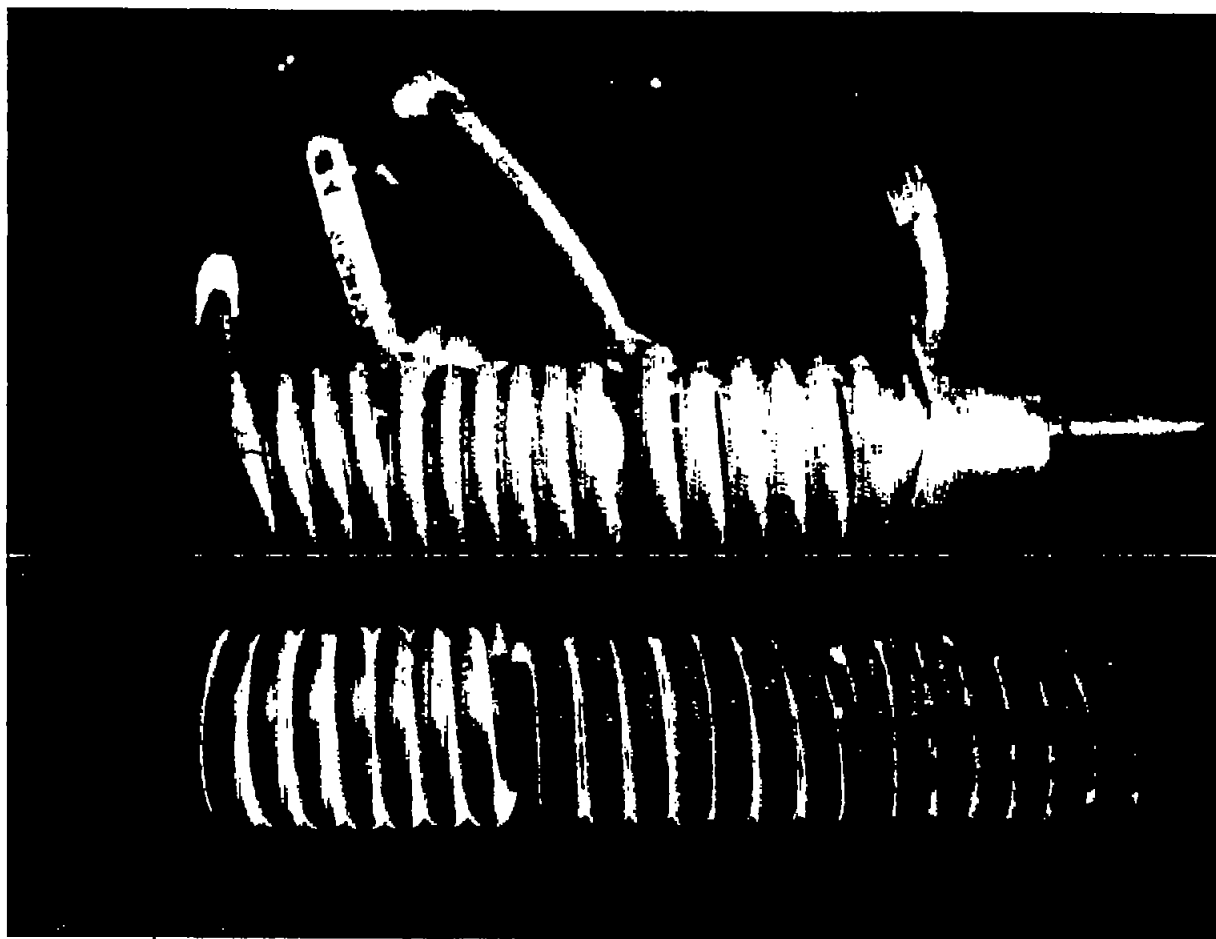
FIG. 2.—Corona on ignition cables on 1-inch arbor. Exposure to corona only 15 minutes at 13 200 volts A. C. and to artificial light 5 seconds to show location of discharge.

Upper mandrel from left to right: Kerite bare, mineral rubber, kerite uncovered.  
Lower mandrel from left to right: Kerite bare, kerite covered, mineral rubber.
